Turkey-Syria earthquake

From 'paradise' to hell

How a luxury development in Turkey became an earthquake death trap

FEBRUARY 28 2023

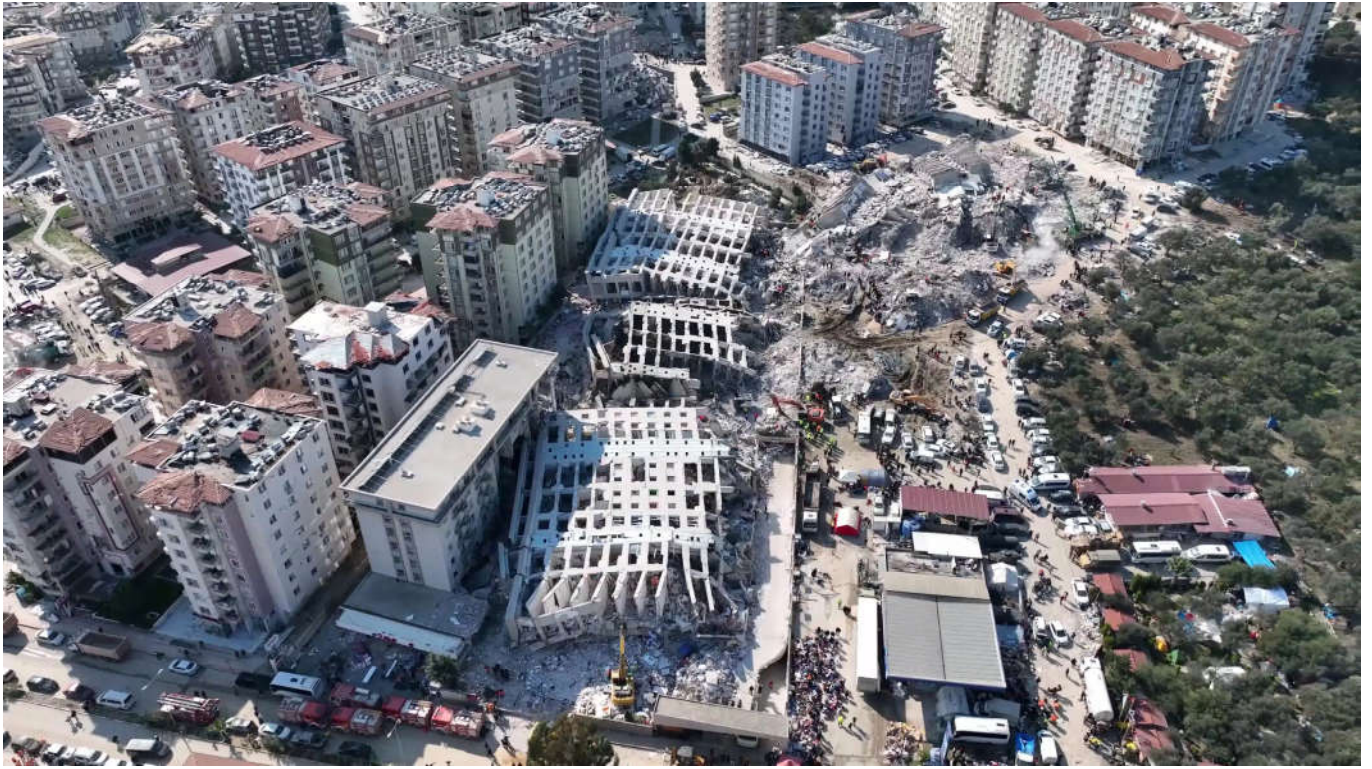
Drone footage shows the 12-storey apartment building collapsed sideways © @adamaxoi

After the quake, one relative of a victim described the building as almost having broken before its sideways collapse. “You are left with a huge pile of rubble with a giant building’s skeleton on top of it. This is what made the rescue so difficult,” he said.

Wernick added: “From the photos, it looks like the walls have pulled off the foundations — probably as a result of the huge tensile forces.”

Drone footage filmed in the aftermath of the earthquake appears to show that the Rönesans split on the **first floor** before collapsing sideways.

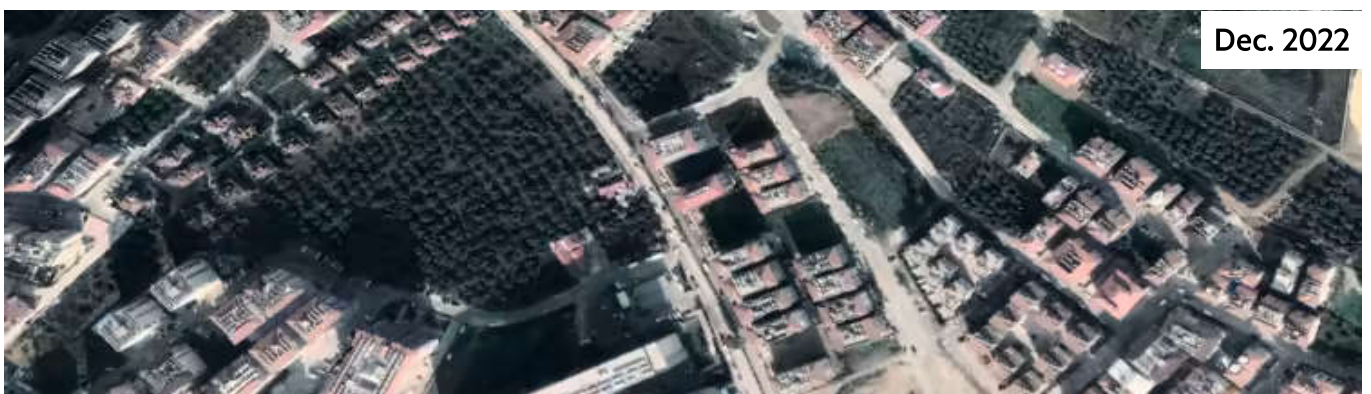
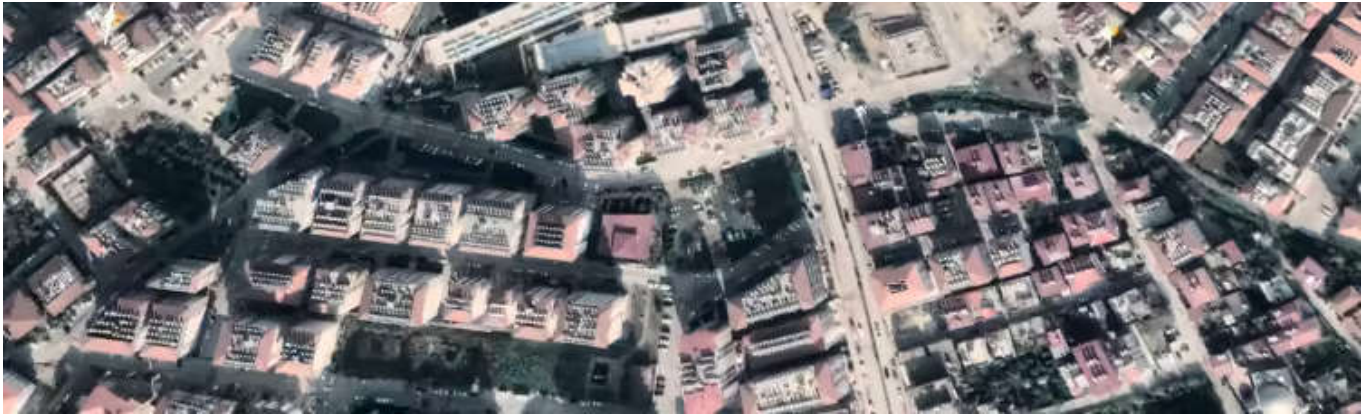
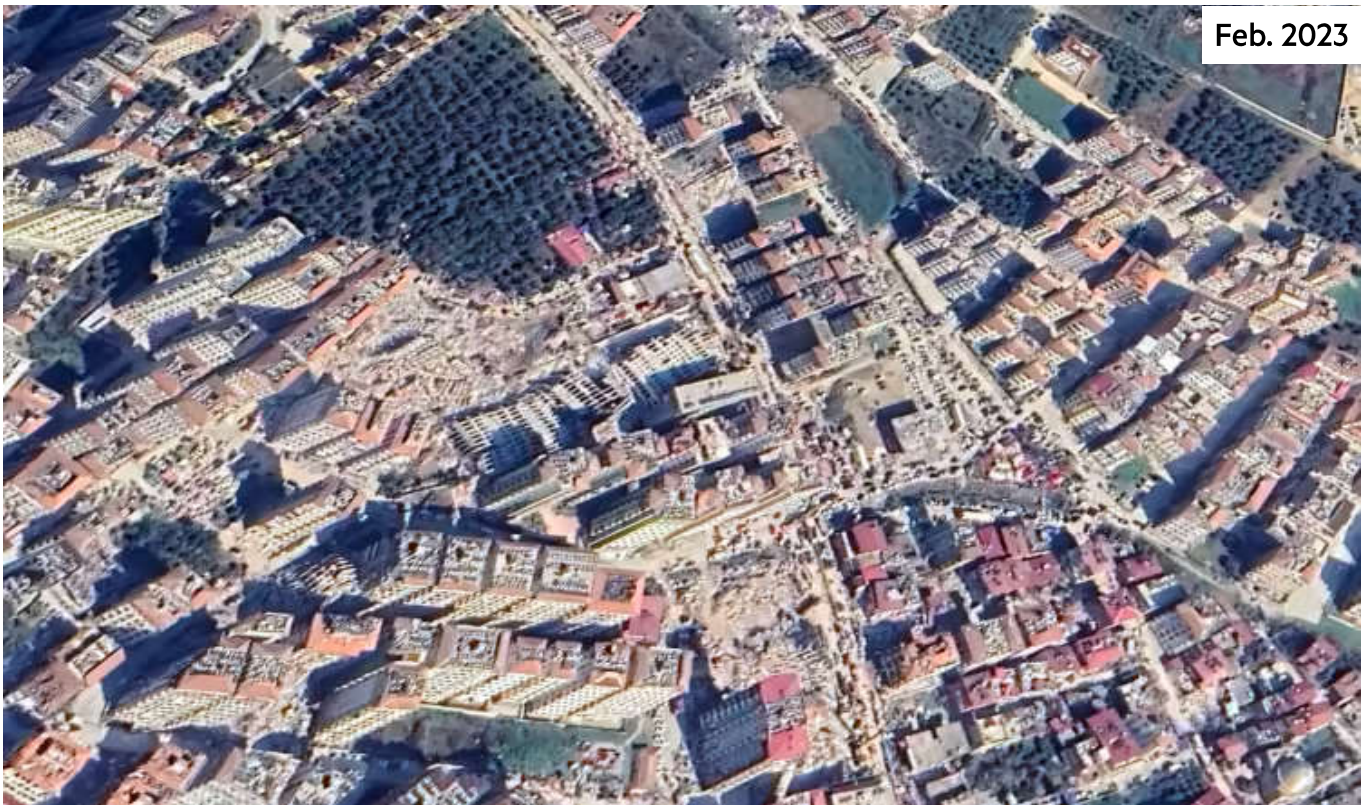
Dec. 2022

Completed in early 2013, the 12-storey building had 249 residential units and two shops. Satellite imagery taken a week later shows the unusual way the apartment building **collapsed**.

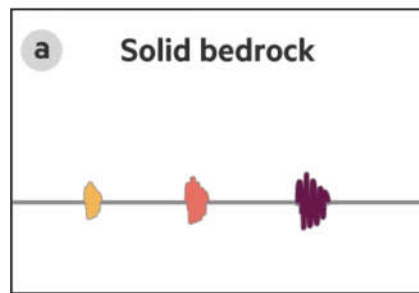
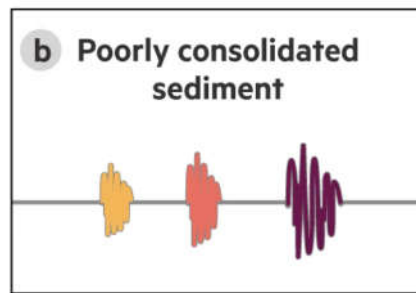
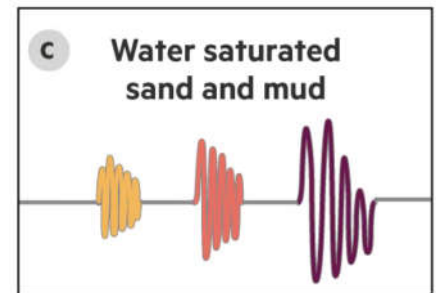
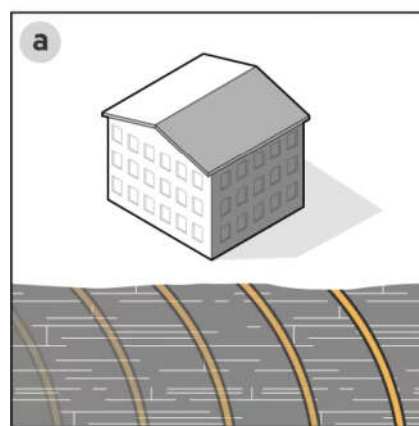
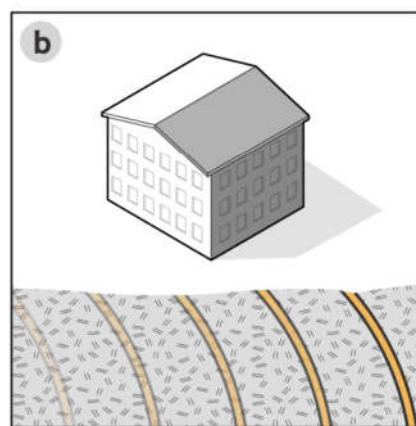
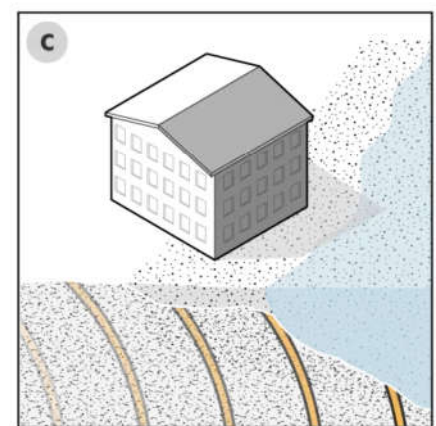
How different types of bedrock affect the degree of impact shockwaves have on buildings during earthquakes

Seismic waves travel through material at different speeds and amplitude — causing varying degrees of damage

Seismograms for each type of bedrock

High-frequency
low-amplitude waves
(less destructive)

Low-frequency
high amplitude waves
(more destructive)

Compressive P waves

Arrive with a compressive bump and rarely cause much damage

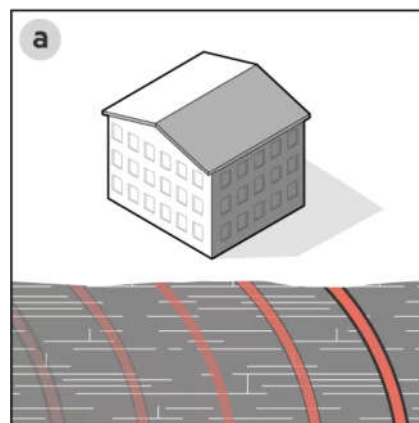
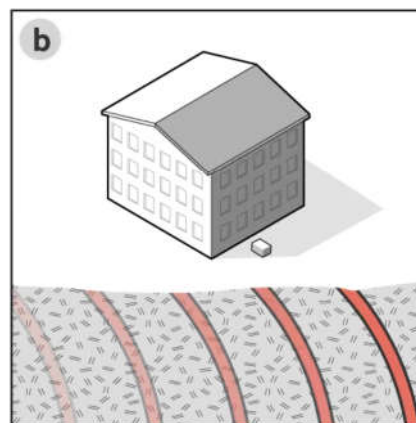
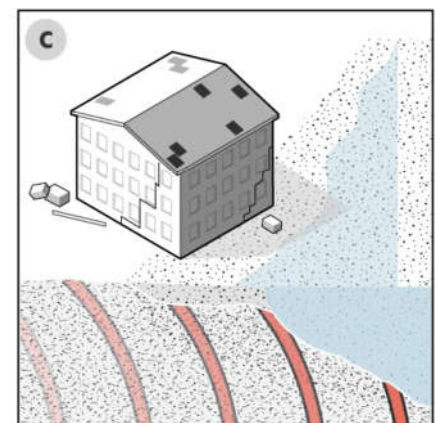
Shearing S waves

Slower moving, and introduce a side-to-side motion that can crack walls and dislodge objects

Rolling surface waves

Slow moving and increasing in size, they ripple the surface, and can cause catastrophic structural failure

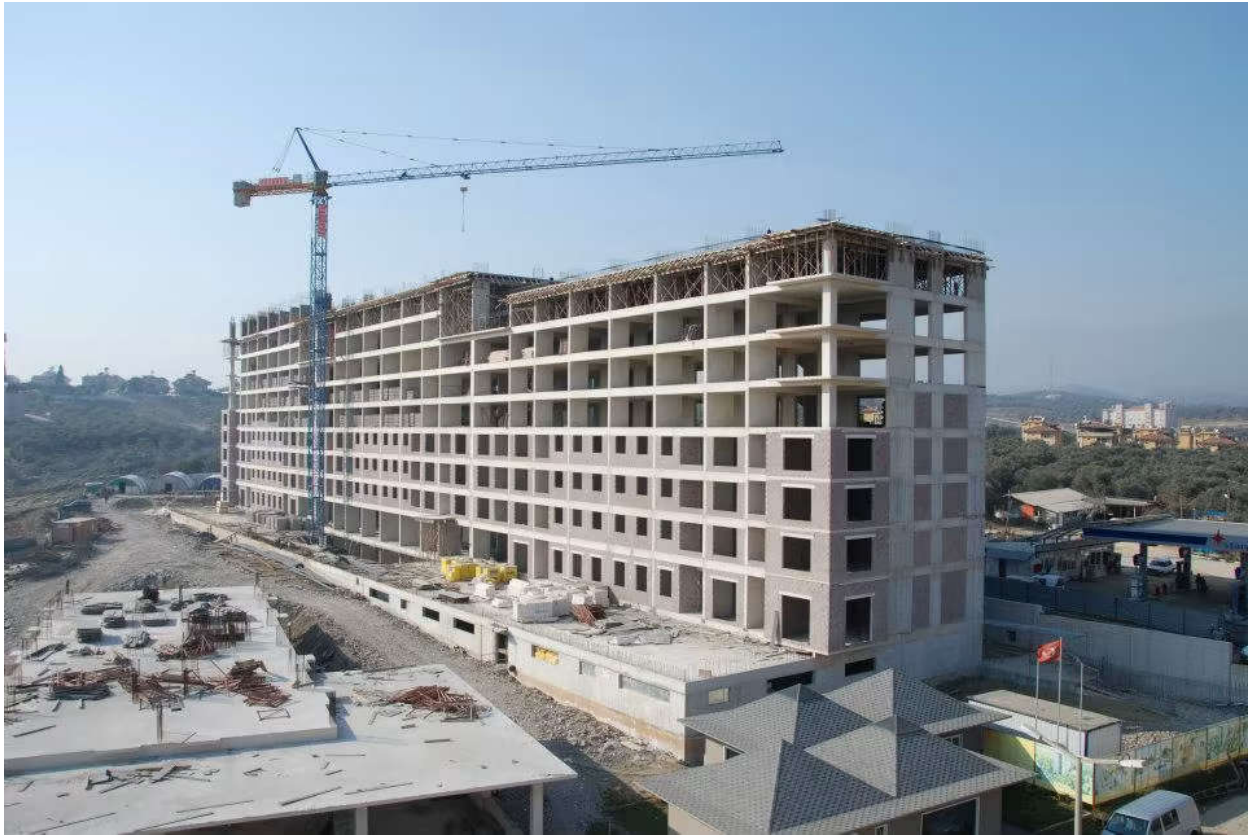
The Röneseans under construction in 2012 © Antis Yapı

The area where the foundations meet the main part of the building will also be closely examined for much the same reason. The risk in earthquakes is that if the top of the building moves against a rigid base, it can tear off and cause a catastrophic loss of stability.

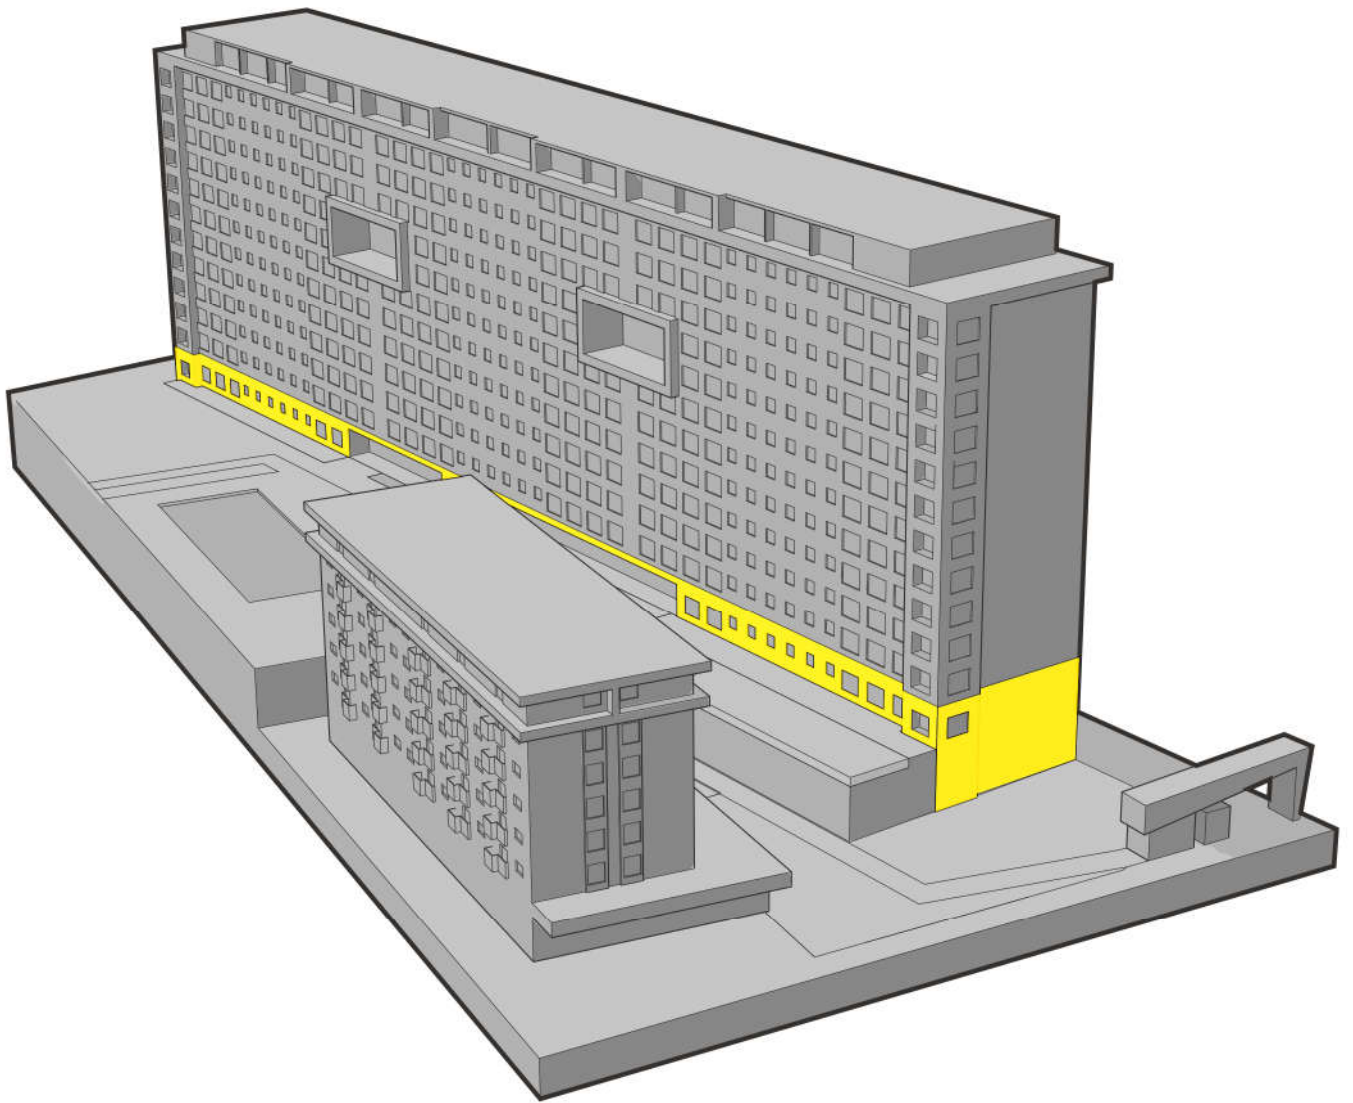
Engineers told the FT extensive analysis would need to be carried out before a building with the **dimensions** of the Rönnesans was constructed in a seismic zone. This would involve making a computer model of a building, including all its internal structures, before stress testing it against estimated earthquake vibrations.

The strength, thickness and quantity of **shear walls** will be one potential line of inquiry. These structural walls bolster a building, prevent swaying and help distribute horizontal forces such as those from the weight of people and furniture — or earthquakes in extreme scenarios — into the foundations and ultimately the earth.

Another area of investigation will focus on the **foundation** and the set up of a garage that appears to be below ground level. Buildings in earthquake prone areas are often built with “piling” pipes dug deep into the earth to support structural stability.

Kahraman said he was also focused on this lower part of the building. The entrance hall to the Röneseans is taller than the other floors. He noted that this imbalance can lead to a problem known as a “soft storey” where one floor is more flexible or less able to withstand earthquake forces, making it a potential weak spot when an earthquake hits.
